Technical Bulletin

Date: June 2020
No: TCM-0620-A
ITCM-0620-A

Product All 50 & 60hz MCS/RCS Ovens

Issue No Heat or Intermittent Heat Complaint

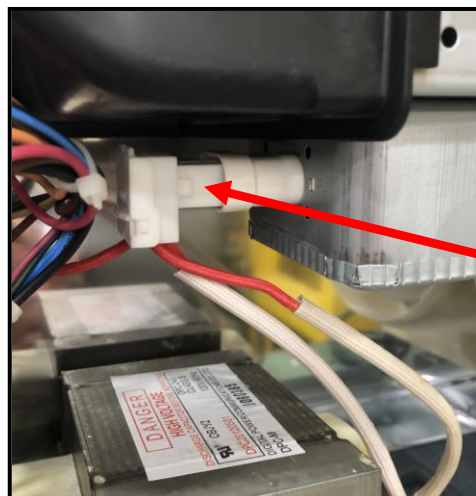
Action Inspect the magnetron's plug-in wire connector. If the connector is discolored and showing signs of overheating (See Figure 1), the issue is a loose wire terminal. A loose high-voltage wire terminal creates enough resistance to prevent proper current flow (milliamps). To correct, tighten/replace the magnetron's loose wire terminal and ensure all high voltage wiring (magnetron, capacitor, diode, & transformer) is tight. Note: The plastic connector cover may be permanently removed.

LOOK FOR DISCOLORATION ON
PLASTIC CONNECTOR COVER
