Technical Bulletin

No: TCM-0028-B
Page 1 of 1

Models Amana RC Chassis Commercial Microwaves Ovens
RC17S, RC17S2, RC17SD2, RC17SD2OSI, RC17SED, RC17SX,
RC22S, RC22S2, RC27S, RC27S2, RC30S, RC30S2,
DQ22HSI, DQ22HSI2, KFC2, KFC2W2,
MC23MP, MC23MPW2, MC23MPT, MC23MPTW2,
ASE7000, ASE70002, ASE9000, ASE90002

Issue Seal holes in Cavity Bottom when replacing Lower Antenna Motor or Oven Tray

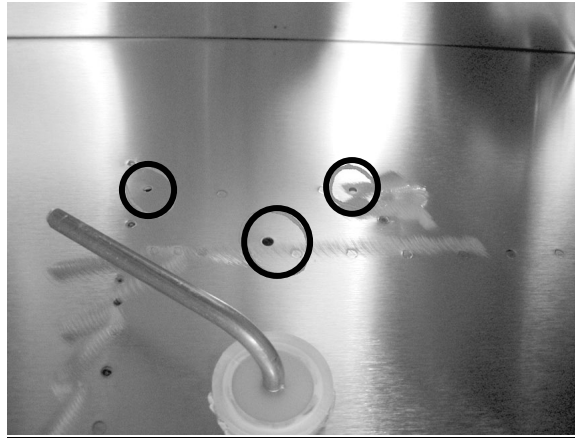
Analysis of failed lower antenna motors has indicated some failures may be caused by grease dripping through these holes and on to the motor.

View from inside cavity with tray removed

Action If replacing the Lower Antenna Motor or Oven Tray on these models, seal the three holes shown below with RTV sealant at the same time.

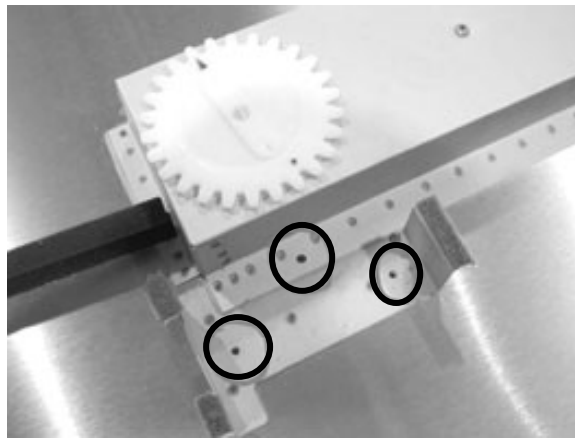
View from under side of cavity with access panel removed
