# Technical Bulletin

**No:** ITCM-0017-B  
Page 1 of 1

**Models** Amana RC Chassis and Menumaster MRC Chassis Commercial Microwave Ovens

**Issue** Seal holes in Cavity Bottom when replacing Lower Antenna Motor or Oven Tray

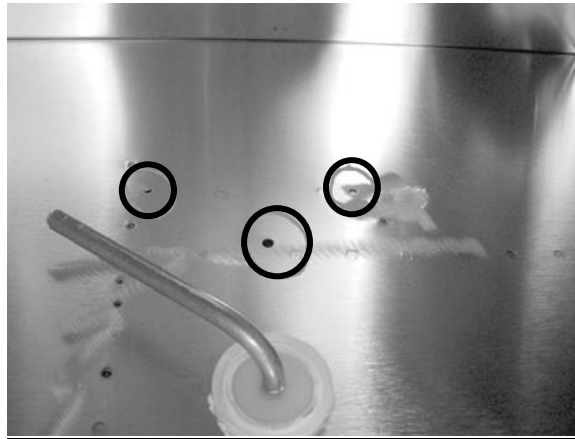
Analysis of failed lower antenna motors has indicated some failures may be caused by grease dripping through these holes and on to the motor.

View from inside cavity with tray removed

**Action** If replacing the Lower Antenna Motor or Oven Tray on these models, seal the three holes shown below with RTV sealant at the same time.

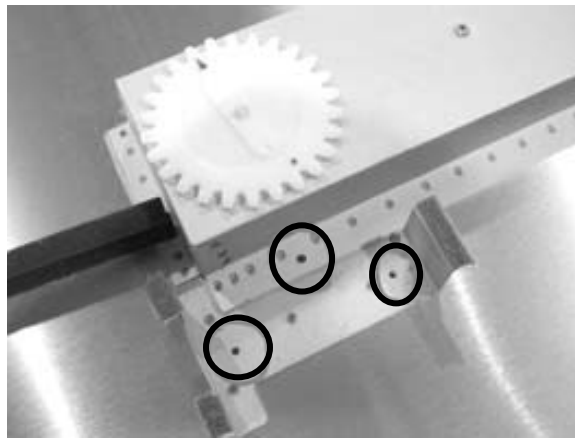
View from under side of cavity with access panel removed
