# Technical Bulletin

No: TCM-0047-B

**Product** AXP20\*, AXP5201, MXP5201, AXP5203, MXP5203 Models

**Issue** Line(s) in the Display

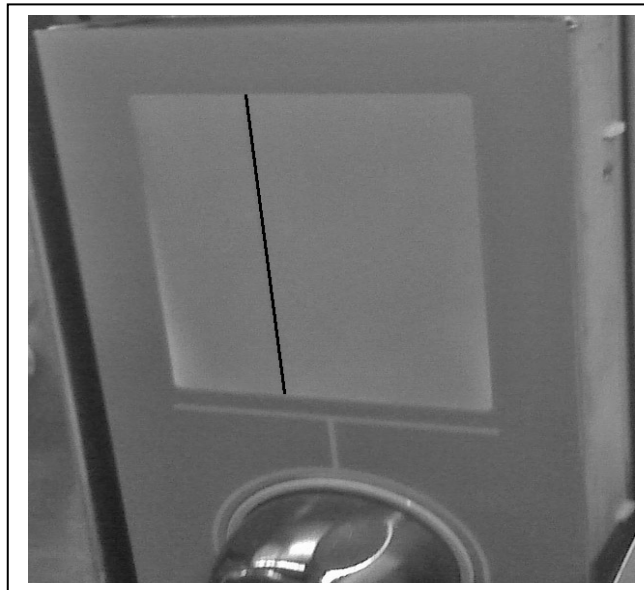
AXP / MXP with line(s) in the display

Should you encounter a complaint of line(s) in the display on an AXP / MXP model, have the customer unplug and plug unit back in. This may clear the fault, however, should the line(s) return the filter board will need to be replaced.

Some early production ovens produced prior to June 2008, with serial number prefix 0805 and earlier, may not have a filter board. If the oven does not have a filter board contact ComServ for assistance.
